CASE STUDY  
CASTLEMILK STABLES

# CASE STUDY

## CASTLEMILK STABLES

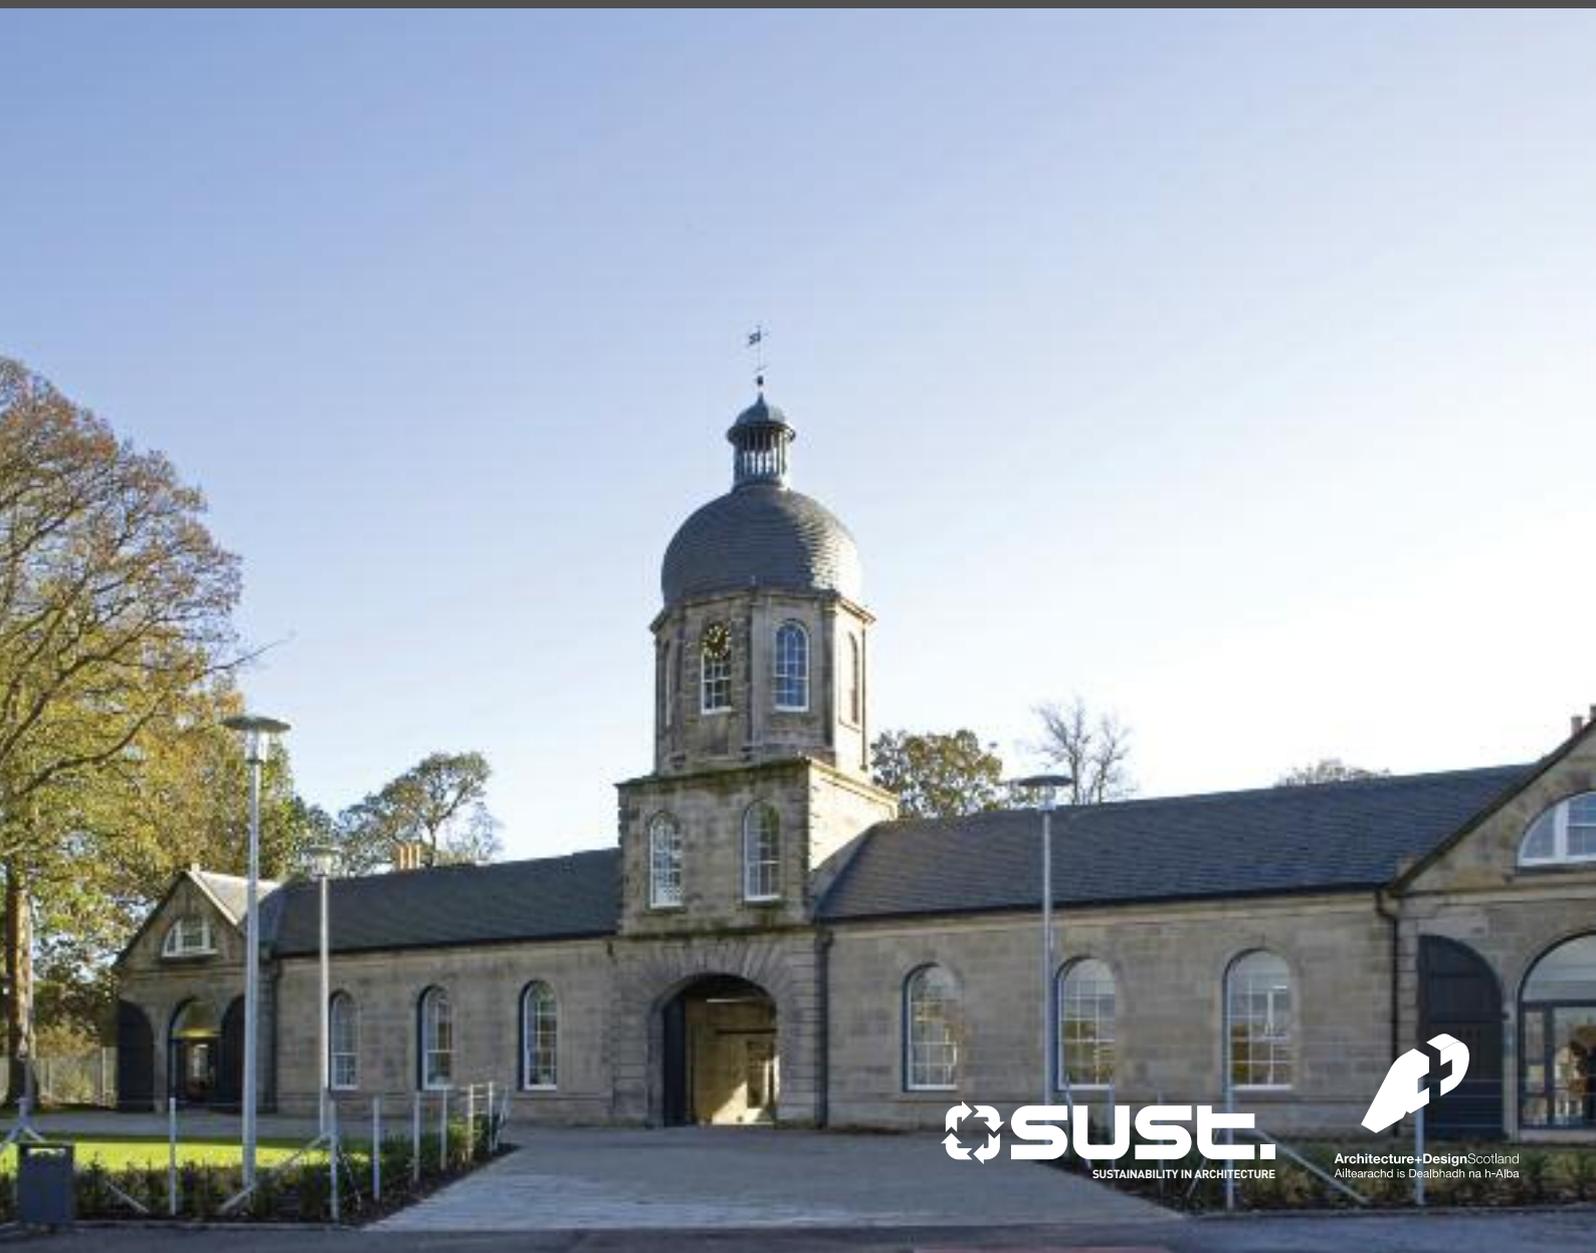
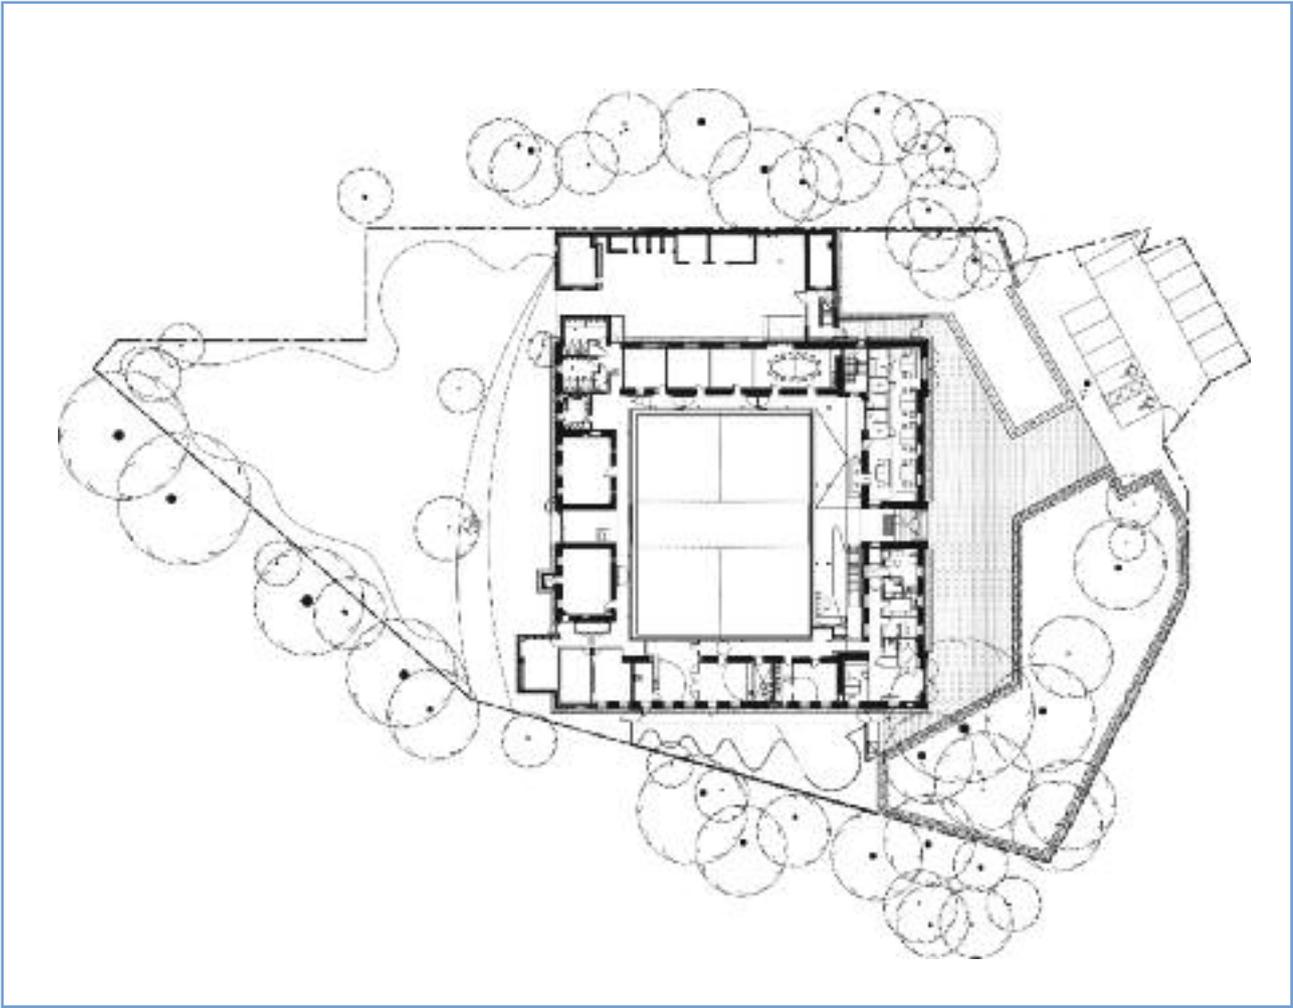
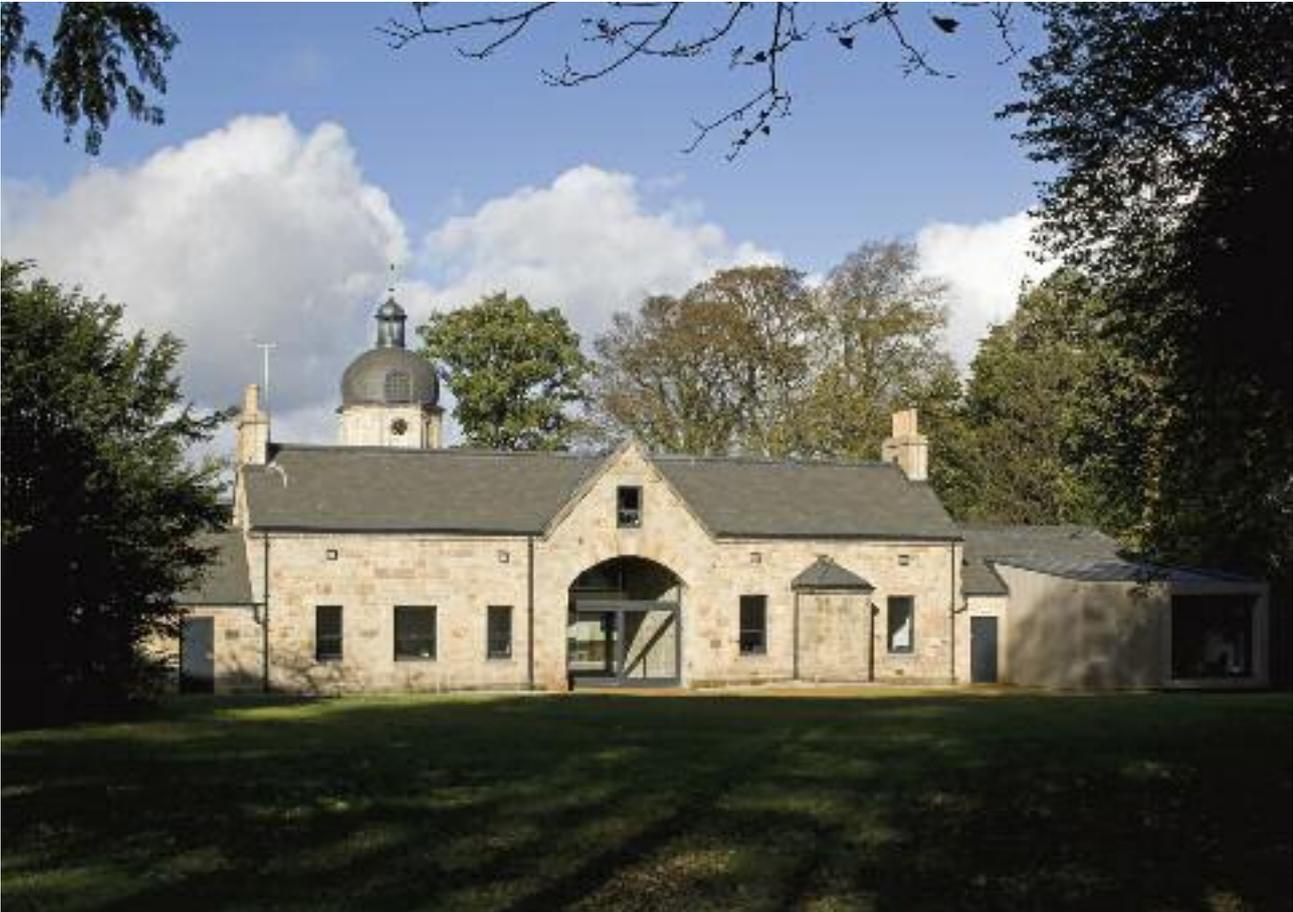
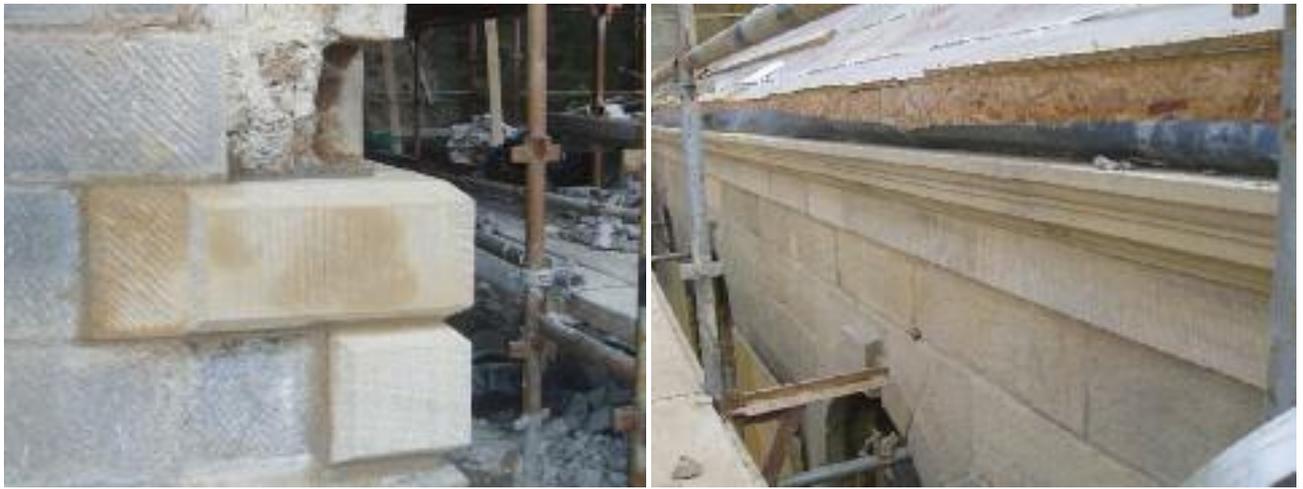
With thanks to Elder and Canon Architects for imagery

Prior to refurbishment, much of the original stonework in the historic part of the building was damaged due to weathering and inappropriate cement repairs. Analysis of the stone found the existing stone to be grit stone, which was probably locally sourced during construction in the 18th century. This type of sandstone is not currently available in Scotland and after analysis of samples by British Geological Survey, Bearn stone, sourced from a Northumbrian quarry, was chosen for both a technical and visual match. Existing lime mortar samples from pointing in the stonework were also matched by the Scottish Lime Centre to prevent future damage from inappropriate mortar in the historic stonework. Generally all elevations were cleaned with a stiff bristle brush to remove lichen, finished off with a light fungicidal wash. The specialist contractor endeavoured to minimise stonework repairs, although some stone indents and a number of full stone repairs were required.

Tooling was applied to the face of the new stone to match adjacent stones. Cement pointing was carefully removed by hand tooling, to avoid damage to arrises (sharp edges to building stone). Alongside traditional materials and good conservation practice, a limited and complimentary palette of new materials and technologies were employed within the inner courtyard, namely structural steel, glass and timber.

Castlemilk stables required indent stone repairs showing best practice principles by retaining as much of the historic stonework as possible. This caused minimal intervention involving the least physical disturbance to the existing building. Stones were only replaced where they had decayed to such a degree that they affected the structural function of the surrounding stonework. Proper matching properties of the replacement indent to the original stone has produced a more successful and long lasting result than simply considering the surface colour without thinking about how the stone will perform, as using unsuitable stone will in the future cause further damage and decay. Close attention was paid to the tooling (the chisel marks and grooves) on the stone indent repairs to match the existing stone. These aspects of stone repair allowed the new stone to work in harmony with the existing historic fabric. The attention paid to detail on the existing fabric is beautifully complimented by the more modern materials and techniques introduced in the courtyard.
